Anterior Biomechanical and Esthetic Failure Leading to Success

Using creative restorative care to accommodate a patient's lifestyle needs

Hugh Flax, DDS, AAACD, MICOI

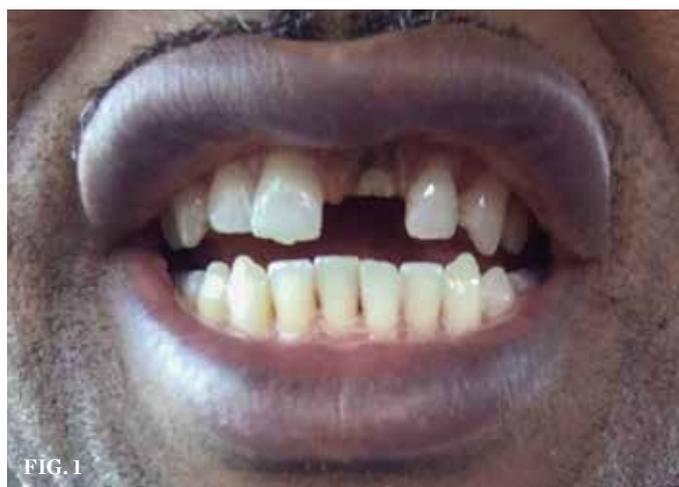
FIG. 1

(1.) Patient presented with a tooth fractured while traveling.

endodontic therapy. About 2 years prior to this case, the tooth turned dark and the patient's dentist advised that he needed a crown. While on a business trip with a temporary crown, he bit into a protein bar and fractured the tooth close to the gumline (Figure 1). The emergency dentist said the tooth broke inside the temporary and needed a post. When the patient returned to Atlanta, his regular dentist delivered the crown without a post. When the patient went out of town again, the crown dislodged, and another emergency dentist adjusted the bite and recemented the crown.

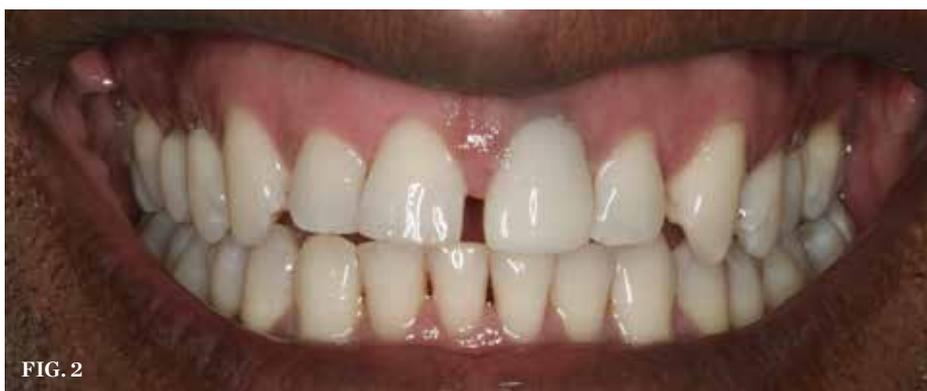
FIG. 2

(2.) The patient's high lip line easily displayed a discolored, ill-fitting crown margin affecting the soft tissue. (3.) Radiograph showed overly aggressive restorative care that weakened the structural predictability.

Our exam discovered that esthetically, the patient displayed the majority of his upper and lower teeth and a large amount of gums when smiling with a scalloped triangular architecture and thin biotype. There were multiple diastemata due to tooth size and arch form (Figure 2). Functionally, though the patient was aware of a clenching habit from stress, there was no fremitus or muscle tenderness evident.

Periodontally, bone levels were adequate, but there was generalized recession in the bicuspid and molar regions, as well as irritated dark tissue around tooth No. 9 that indicated a biologic width issue from restorative infringement of the periodontal complex. Restoratively, the lack of ferrule at tooth No. 9 was inadequate for long-term stability of the restoration. Endodontic care and restorative procedures had decreased dentinal volume and made the tooth less fracture resistant as well (Figure 3). The rest of the dentition was intact with abundant enamel to resist decay risk factors as long as home care was excellent and the saliva remained non-acidic.

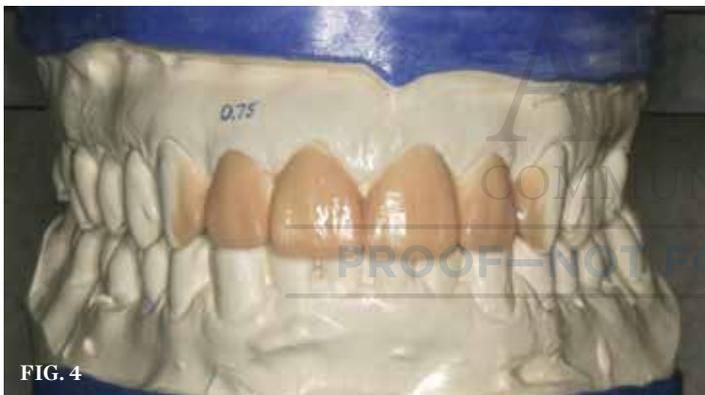
FIG. 4

(4.) The diagnostic blueprint detailed a plan for success. (5.) Post-extraction provisionalization disguised the changes that were taking place and gave the patient peace of mind during his care so tissues could heal properly. (6.) Proper orientation of osteotomies created ideal outcomes for implants' restorative care. (7.) Post-surgical CBCT confirmed ideal placement of the implant.

Since implant placement is ideally prosthetically driven,⁹ facial planning records were taken to establish midline and incisal edge placement using a stickbite and a Kois Dento-Facial Analyzer (Panadent, www.panadent.com). This was done after the patient had been equilibrated using an anterior deprogrammer to give the lab technician an accurate centric relation bite record. While a functional wax-up (Figure 4) was being created, the patient had power bleaching performed to establish a prior to this case, whiter and more attractive yet still natural color for his smile.

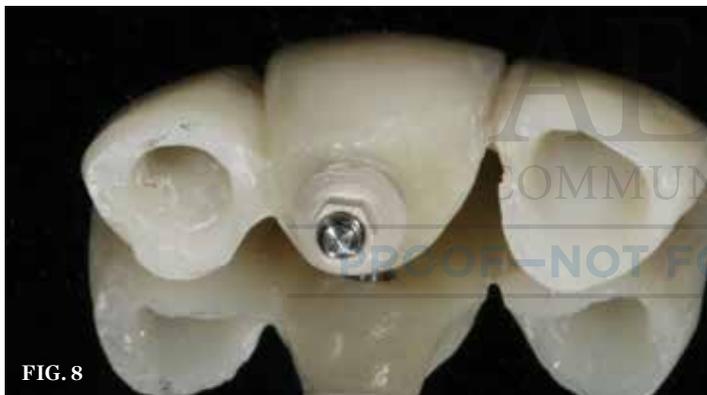
FIG. 8

(8.) The updated screw-retained provisional allowed soft tissue architecture to mature. **(9.)** Preserving the periodontal interface on the impression coping is critical. The composite cap made the screw easily retrievable after the impression has hardened. **(10.)** A well-fitting resin seating jig accurately allowed the abutment to be precisely indexed to the implant. **(11.)** A natural and pleasing smile made the patient more confident.

Three months later, to develop the restorative soft tissue profile around the implant, the provisional bridge was converted to a screw-retained crown by carving a shell out of the pontic and luting it to a temporary abutment that was placed on the implant,⁴ accessed with a tissue punch and erbium laser. After meticulous contouring and polishing of the screw-retained portion (Figure 8), the provisional was recemented on the abutments on teeth Nos. 8 and 10. The author then hand tightened the abutment on tooth No. 9 and sealed the lingual with cotton and composite to protect the abutment. The patient was given detailed home care instructions by our staff prior to a 2-month international trip.
