## Anterior Biomechanical and Esthetic Failure Leading to Success

Using creative restorative care to accommodate a patient's lifestyle needs

Hugh Flax, DDS, AAACD, MICOI

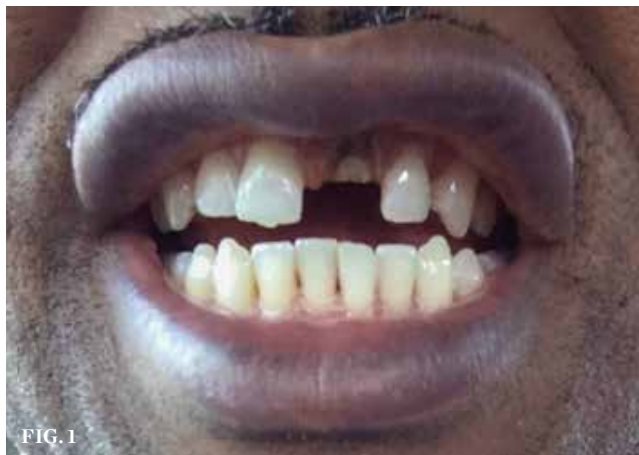
FIG. 1

(1.) Patient presented with a tooth fractured while traveling.

endodontic therapy. About 2 years prior to this case, the tooth turned dark and the patient's dentist advised that he needed a crown. While on a business trip with a temporary crown, he bit into a protein bar and fractured the tooth close to the gumline (Figure 1). The emergency dentist said the tooth broke inside the temporary and needed a post. When the patient returned to Atlanta, his regular dentist delivered the crown without a post. When the patient went out of town again, the crown dislodged, and another emergency dentist adjusted the bite and recemented the crown.

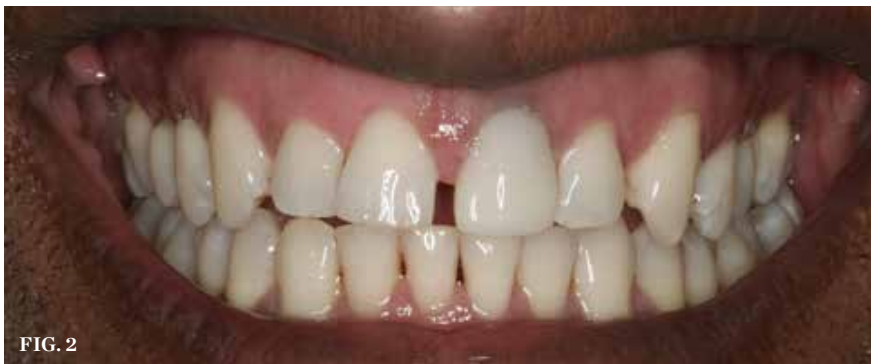
FIG. 2

(2.) The patient's high lip line easily displayed a discolored, ill-fitting crown margin affecting the soft tissue. (3.) Radiograph showed overly aggressive restorative care that weakened the structural predictability.

Our exam discovered that esthetically, the patient displayed the majority of his upper and lower teeth and a large amount of gums when smiling with a scalloped triangular architecture and thin biotype. There were multiple diastemata due to tooth size and arch form (Figure 2). Functionally, though the patient was aware of a clenching habit from stress, there was no fremitus or muscle tenderness evident.

Periodontally, bone levels were adequate, but there was generalized recession in the bicuspid and molar regions, as well as irritated dark tissue around tooth No. 9 that indicated a biologic width issue from restorative infringing of the periodontal complex. Restoratively, the lack of ferrule at tooth No. 9 was inadequate for long-term stability of the restoration. Endodontic care and restorative procedures had decreased dentinal volume and made the tooth less fracture resistant as well (Figure 3). The rest of the dentition was intact with abundant enamel to resist decay risk factors as long as home care was excellent and the saliva remained non-acidic.

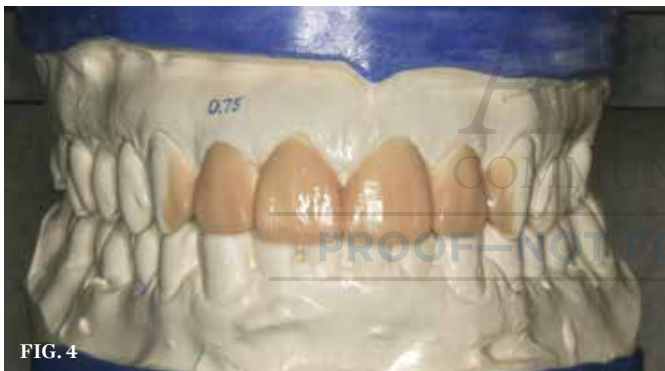
FIG. 4

(4.) The diagnostic blueprint detailed a plan for success. (5.) Post-extraction provisionalization disguised the changes that were taking place and gave the patient peace of mind during his care so tissues could heal properly. (6.) Proper orientation of osteotomes created ideal outcomes for implants' restorative care. (7.) Post-surgical CBCT confirmed ideal placement of the implant.

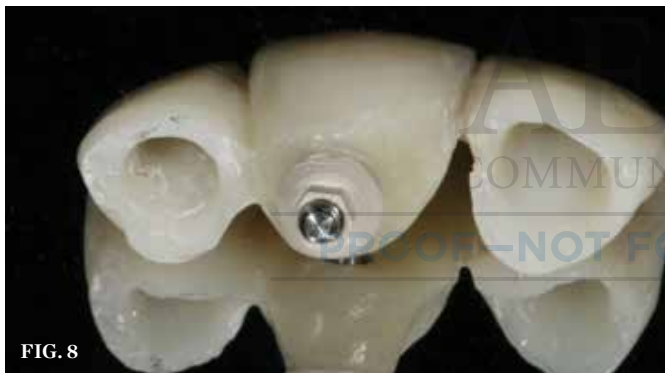
FIG. 8

(8.) The updated screw-retained provisional allowed soft tissue architecture to mature. (9.) Preserving the periodontal interface on the impression coping is critical. The compule cap made the screw easily retrievable after the impression has hardened. (10.) A well-fitting resin seating jig accurately allowed the abutment to be precisely indexed to the implant. (11.) A natural and pleasing smile made the patient more confident.

Three months later, to develop the restorative soft tissue profile around the implant, the provisional bridge was converted to a screw-retained crown by carving a shell out of the pontic and luting it to a temporary abutment that was placed on the implant,<sup>4</sup> accessed with a tissue punch and erbium laser. After meticulous contouring and polishing of the screw-retained portion (Figure 8), the provisional was recemented on the abutments on teeth Nos. 8 and 10. The author then hand tightened the abutment on tooth No. 9 and sealed the lingual with cotton and composite to protect the abutment. The patient was given detailed home care instructions by our staff prior to a 2-month international trip.
